Manhole Inspection Summary

Manhole # S35CC_006MH

Insp Date: **10/31/07 12:37 PM**

Location Address: **920 hargrove**

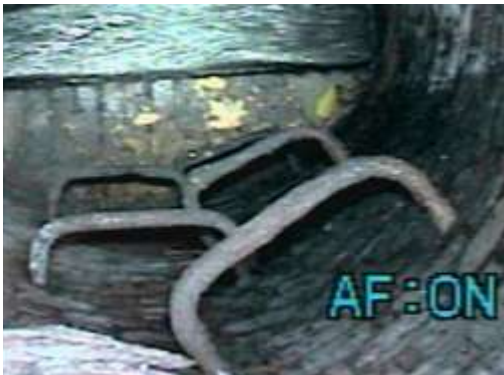
Defect 1

Steps Count: **6** Missing: **0** ☒ **Corroded**

steps

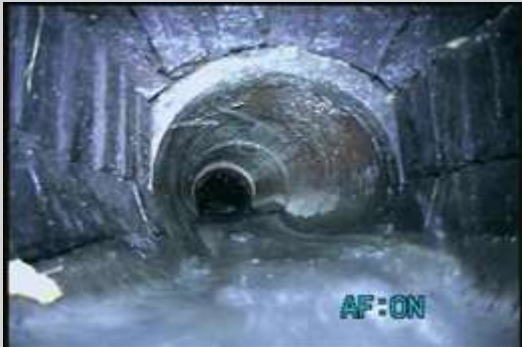
12 O'Clock Outflow

10 in. Circular Gravity Sewer
Pipe Out @ 12 O'Clock

Pipe Material: **Clay** ☐ Pipe Lined

Invert Depth: **10.40** (ft.) Flow Characteristics: **Fast**

Deposits: ☒ None ☐ Mud ☐ Sludge ☐ Debris ☐ Grease

Infiltration: **None** Pipe Seal Cond: **Unknown**

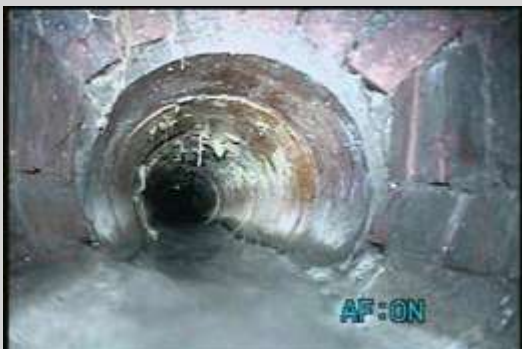
6 O'Clock Inflow

10 in. Circular Gravity Sewer
Pipe In @ 6 O'Clock

Pipe Material: **Clay** ☐ Pipe Lined

Invert Depth: **10.30** (ft.) Flow Characteristics: **Fast**

Deposits: ☒ None ☐ Mud ☐ Sludge ☐ Debris ☐ Grease

Infiltration: **None** Pipe Seal Cond: **Unknown**
